Optimisation of Concrete Casting: Impact of Using Vibrators on the Mechanical Properties and Strength of Concrete Structures

Awang Muhammad Alief¹, Rusandi Noor^{1*}, Bagus Laksana²

Keywords: Concrete quality control, Vibrator, Hammer test, Concrete

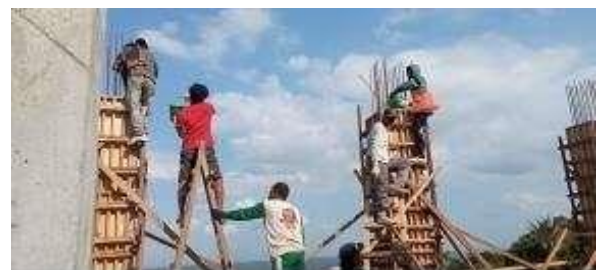
Figure 2.2 Workers Doing Casting Manually

As seen in Figure 2.2, the column casting process can be seen that the workers are casting without using a vibrator (manual).

1. When casting manually, you must use a vibrator so the concrete castings can fill the entire column volume evenly.
2. When shooting the hammer at the column, beam and plate samples, you must be more careful because the shooting position can affect the rebound value.
3. Prevention of Vibrator errors is done by maximising the compensation with the Vibrator. Construction

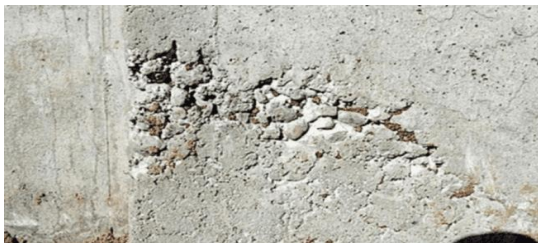
Figure 3.1 Image of Voids and Honeycomb

You can see in Figure 3.1 relatively deep and wide holes in the concrete, known as Voids or Honeycomb. Voids are formed when concrete fails to fill areas in the formwork. Usually, voids occur because the concrete is stuck due to the placement of the concrete being too deep or in areas where the reinforcement is too close. Honeycombs form when mortar fails to fill the voids between coarse aggregate particles. The causes of Honeycomb and Voids include concrete slump that is too low, segregation, the distance between reinforcements that are too close, poor compaction implementation, and improper pouring. Almost all Void damage results in structural damage, while Honeycomb damage can be structural or non-structural. Structural depending on the location of the Honeycomb area. It can also be seen in Figure 3.4 that the defects in the columns were caused by manual casting, and can be seen in Figure 3.3 the empty spaces in the beams due to not using a concrete vibrator when casting, which caused spaces/cavities in the casting results of the beams. It can be seen in Figure 3.2 that there are crack width tolerances and structural types and conditions.

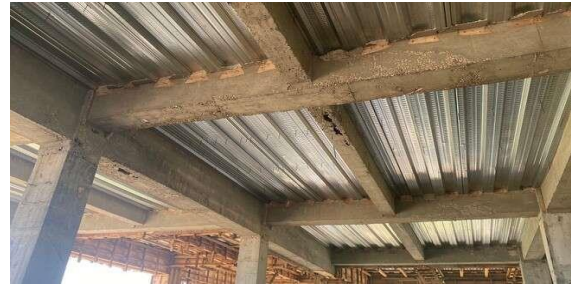
Figure 3.3 Documentation of Deformed Beam

A 3-story building construction project is the background for this research, where various column and beam sizes have been used with specific details for each type. However, problems occurred due to delays in the casting schedule and not using vibrators during the casting process. As a result, some columns, beams, and plates experience deformities or lack shape due to extreme pressure and weather effects on the

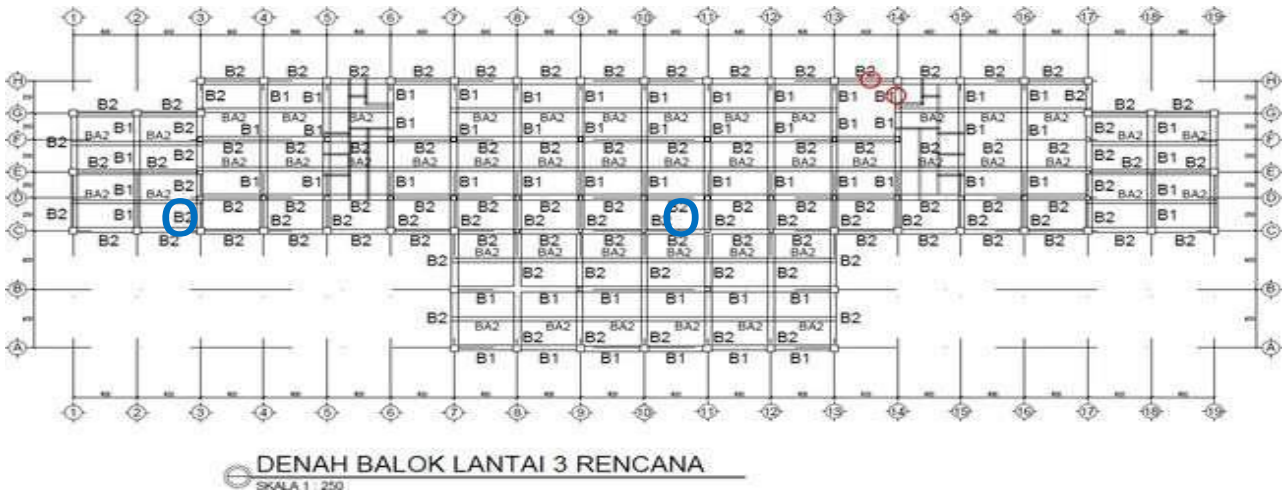
Figure 3.8 Hammer Test Points for Beams and Plates

Hammer Test Plate: ○ Hammer Test Beam: ○

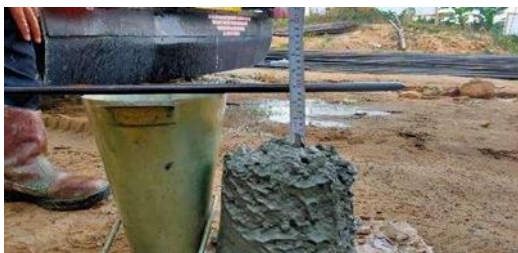
Figure 3.9 Slump Test

An average of 7 cm, as seen in Figure 3.9, where the slump value meets the planned slump value. From visual

observation, it can be seen that fresh concrete has good adhesive properties between paste or mortar and aggregate so that segregation and bleeding do not occur. [7]

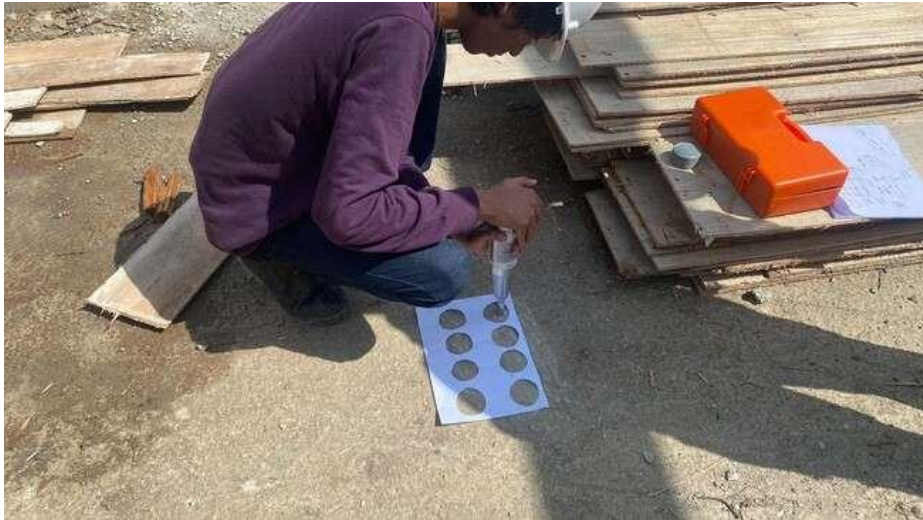
Figure 4.0 Self-Documentation of Hammer Test Plates in the Field

It can be seen in Figures 4.0 & 4.1. This Hammer Test was carried out directly at the Advanced Development Project of SMA Negeri 17 Samarinda, taking 8 column samples with 10 points in one

It can be seen in Table 4.3 that the results of the hummer-free compressive strength test on beams and plates show that the results for the beams themselves meet the standards. As for the plates themselves, the average calculation results in the table show that they do not meet the standards for the compressive strength of the concrete itself.
