Structure Performance on the Long Span Bridge in Riau Province (Case on Siak I Bridge)

Abstract – Siak I Bridge is located in Pekanbaru City and was constructed in 1975 and used in April 1977. The bridge has undergone a functional change; initially, Siak I Bridge served as a Class IIA collector road but was later reclassified as a Class I arterial road. This change resulted in performance degradation due to cracking in the piers/columns, which has been repaired using grouting methods and reinforced with steel jackets. Cracks were also observed on the deck slab, and grouting has been applied to these cracks as well. Therefore, an evaluation of the bridge's serviceability and a structural strengthening study are necessary. The methods used in structural assessment/research include Ultrasonic Pulse Velocity (UPV) testing, thickness test, rebar scanning, dynamic loading test and frequency testing. These tests aim to verify the bridge's serviceability capacity. Based on the vibration frequency tests conducted on the bridge, there are three points where the actual vibration frequencies are lower than the theoretical natural frequencies. Meanwhile, thirteen other points show actual frequ

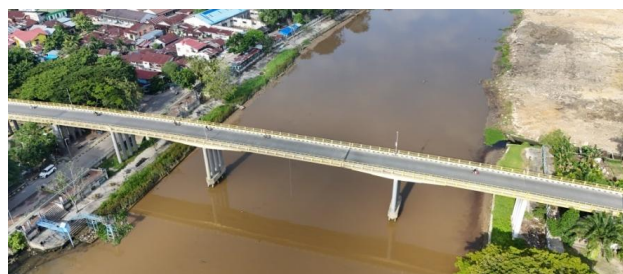
Figure 1. Siak I Bridge

Siak I Bridge, is a long span bridge located in Pekanbaru City, Riau Province. The bridge was constructed in 1975, and officially inaugurated in April 1977.

It features a simple composite steel girder superstructure with a “Gerber”-type configuration at the

center span. The substructure consists of column-shaped piers supported by steel pile foundations. The bridge comprises 13 spans with a total length of 350 meters (125 m – 150 m – 75 m). The bridge deck has a width of 7.32 meters and a thickness ranging from 18 cm to 20 cm. The piers consist of four circular columns, each with a diameter of 95 cm, and are supported by steel pile foundations with a diameter of 40 cm.

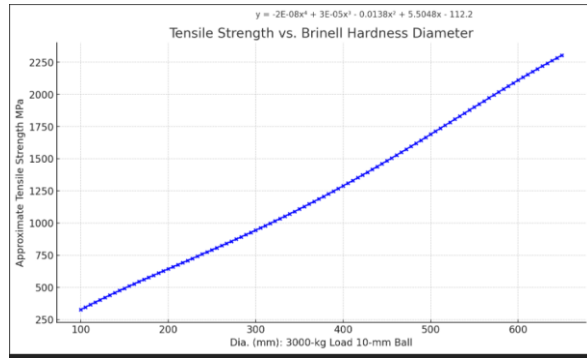
Figure 3. Conversion of HB values to MPA (UTS)

The results of the steel hardness test on the Siak I Bridge constitute the data used to estimate the steels quality by correlating the hardness values obtained. These hardness value were then interpreted according to the ASTM E 140-97 TENSILE STRENGTH TO HARDNESS CONVERSION CHART, which serves as the standard reference for hardness conversion of metals (based on ASTM E10-08/Brinell test: Standard Hardness Conversion Tables for Metals). The relevant tables and graph are presented below.

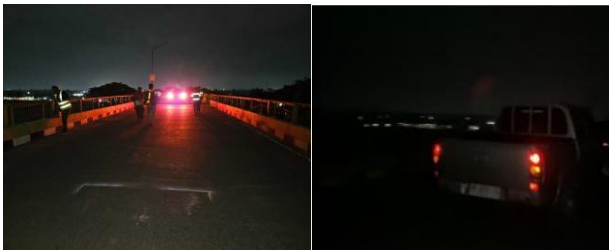
Figure 6. Implementation of the Moving Load Test

In the Moving Load testing method, a fully loaded truck is driven across the entire bridge span at designated speeds of 20, 30, 40 km/h to evaluate the dynamic response of the structure

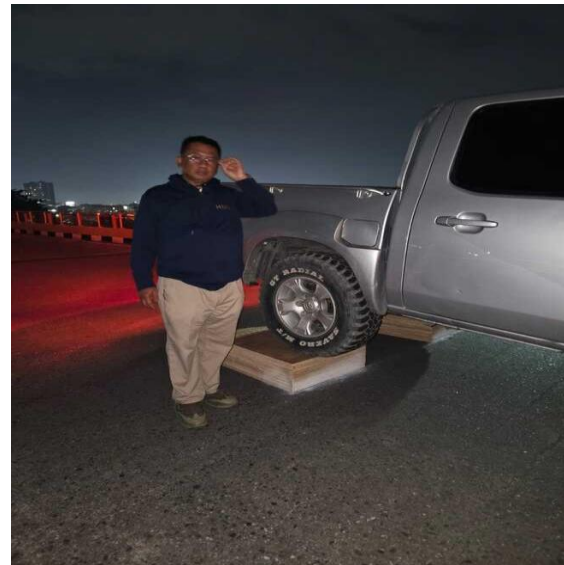
Figure 8. Implementation of Jumping Load

The Jumping Load testing method was conducted at the $\frac{1}{4}$, $\frac{1}{2}$, $\frac{3}{4}$ spans of the bridge by driving truck/vehicle over a speed trap.
